IMPACT OF STRUCTURAL MODIFICATIONS ON RELIABILITY AND LONGEVITY OF MECHANICAL SYSTEMS UNDER OPERATIONAL CONDITIONS

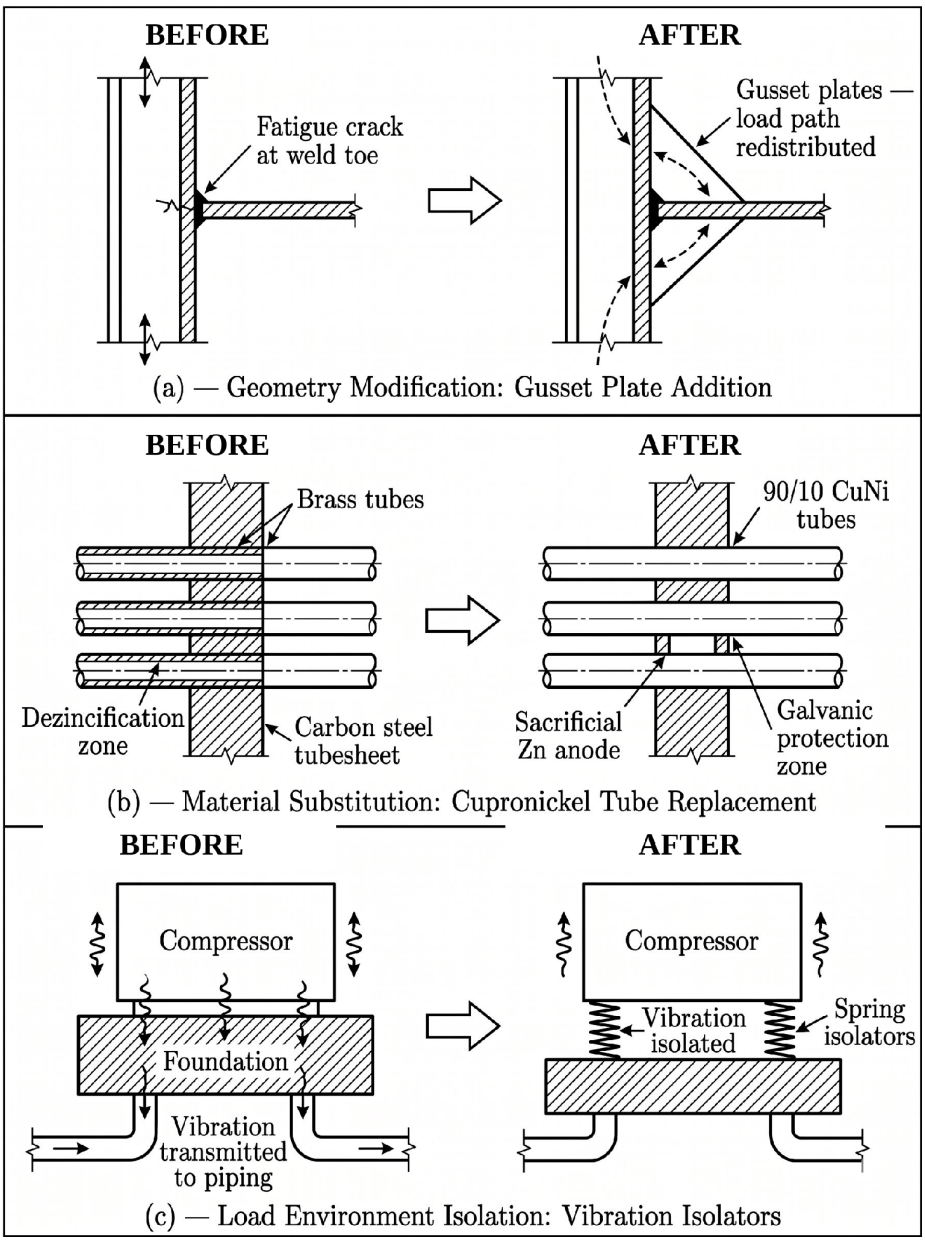
A T-joint in a pump support frame developed fatigue cracks at the fillet weld toe three times over five years, at intervals of 22, 20, and 16 months (Figure 1a, left panel). Pre-intervention failure rate: λ_{pre} = 3 failures / 58 months = 0.052 failures per month (MTBF ≈ 19.3 months).

Brass condenser tubes (CDA 443) in a seawater-cooled heat exchanger failed by dezincification four times over six years at 18–24 month intervals, producing tube perforations requiring plugging (Figure 1b, left panel). Pre-intervention failure rate: λ_{pre} = 4 failures / 72 months = 0.056 failures per month (MTBF ≈ 18 months).

A reciprocating compressor (720 rpm, excitation frequency 12 Hz) transmitted vibration through its foundation into adjacent piping, causing three socket weld fatigue failures over 42 months at approximately 14-month intervals (Figure 1c, left panel). Pre-intervention failure rate: λ_{pre} = 3 failures / 42 months = 0.071 failures per month (MTBF ≈ 14 months).

Fig. 1. Engineering schematics of three structural interventions:

(a) gusset plate addition to pump support frame T-joint;

(b) cupronickel tube replacement with sacrificial anode protection in seawater cooler;

(c) spring vibration isolator installation on compressor foundation

Engineering intervention consisted of welding two triangular gusset plates on opposite sides of the T-joint, redistributing the load path from the single weld toe to the gusset-to-beam weld line over a 120-mm contact length (Figure 1a, right panel). Hot-spot stress at the original crack location, measured by strain gauges before and after installation, decreased from 185 MPa to 98 MPa, a reduction of 47 percent. The modified joint configuration was reclassified to a higher FAT category per Hobbacher [5], and the reduced hot-spot stress placed the detail within the safe region of the applicable S-N curve at the estimated service cycle count, consistent with indefinite fatigue life under the operating load spectrum.

All 126 tubes were replaced with 90/10 cupronickel (UNS C70600), eliminating the dezincification-susceptible phase (Figure 1b, right panel). The cupronickel-to-carbon-steel tubesheet junction created a galvanic cell (~200 mV in aerated seawater), managed by sacrificial zinc anodes sized at ~4.5 kg/year [8; 9].

Four steel coil spring isolators (natural frequency 3.5 Hz, frequency ratio 3.4, transmissibility ~0.10) were installed between skid and foundation (Figure 1c, right panel). Vibration velocity decreased from 18.5 to 3.7 mm/s RMS, an 80-percent reduction [6; 7].

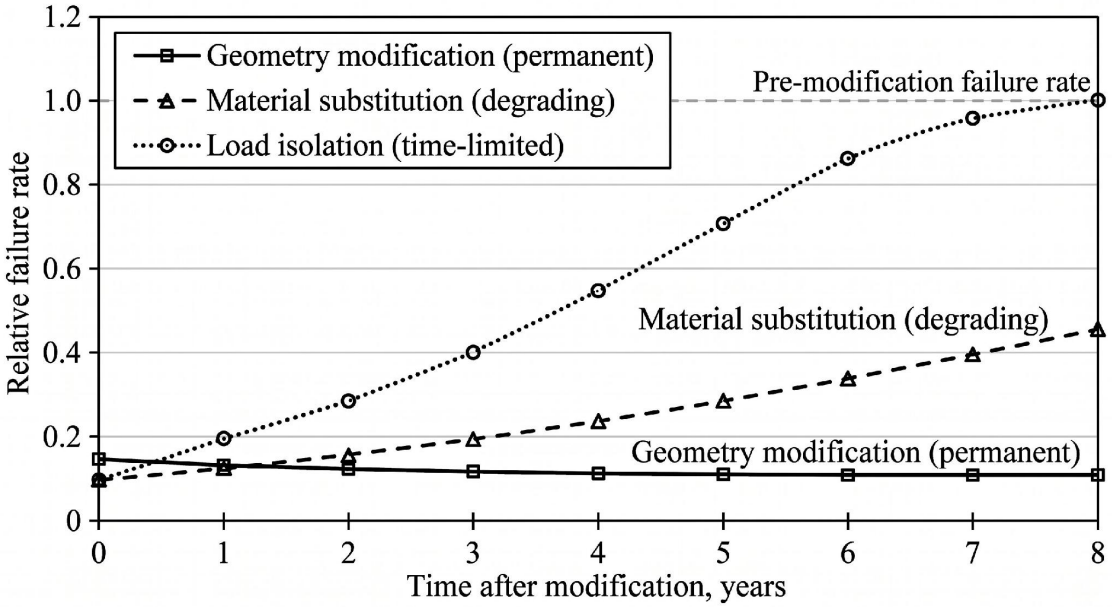
Figure 2 presents an illustrative projection of relative failure rate over eight years, based on the degradation patterns observed in the case studies: Case A (solid) remains flat near zero; Case B (dashed) rises gradually as anodes are consumed; Case C (dotted) rises steeply, approaching pre-intervention levels by year 7–8.

Fig. 2. Illustrative failure rate trajectories after structural intervention (conceptual representation based on observed engineering trends): geometry alteration (permanent), material substitution (degrading), and load environment isolation (time-limited)

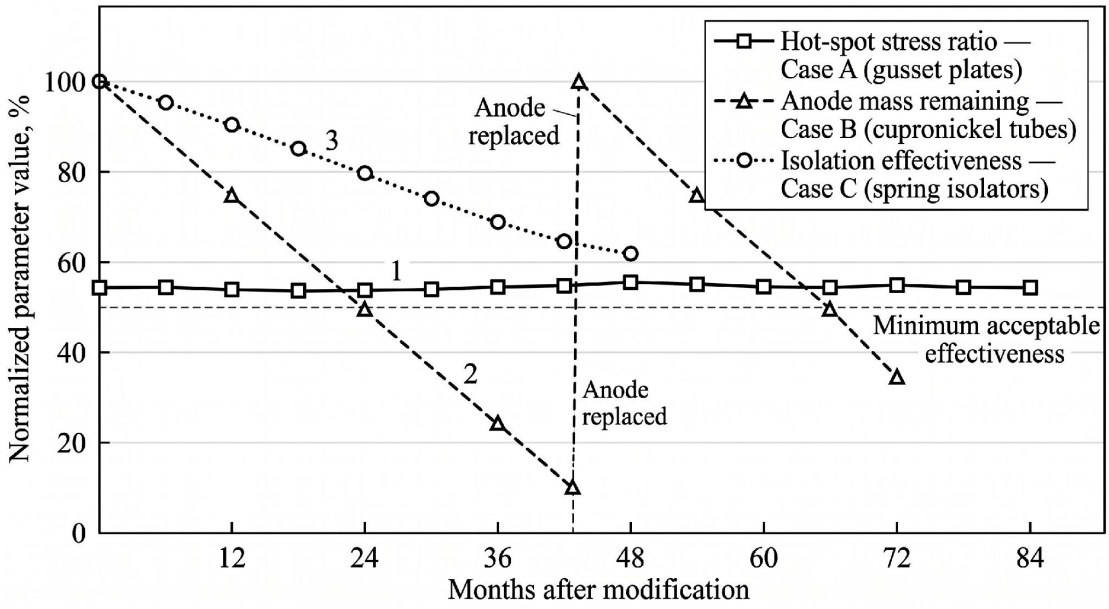
Figure 3 presents the measured degradation data for each case, normalized to a common percentage scale. Case A (solid line, hot-spot stress ratio) remains at 55 percent of the pre-intervention value across all 84 months with no discernible trend. Case B (dashed line, anode mass remaining) declines linearly from 100 percent to approximately 10 percent over 42 months, jumps to 100 percent upon anode replacement, and resumes the same linear decline. Case C (dotted line, isolation effectiveness) follows a concave path from 100 percent to 62 percent over 48 months, with the decline rate decreasing in the later measurement intervals. A

horizontal reference line at 50 percent marks the minimum acceptable effectiveness threshold for Case C.

Fig. 3. Normalized post-intervention monitoring data: hot-spot stress ratio (Case A), anode mass remaining (Case B), and isolation effectiveness (Case C)
